# *Stowe by Chartley Parish Council*

**Concerns with regards to proposed Solar Farms in Drointon, and Newton in Staffordshire.**

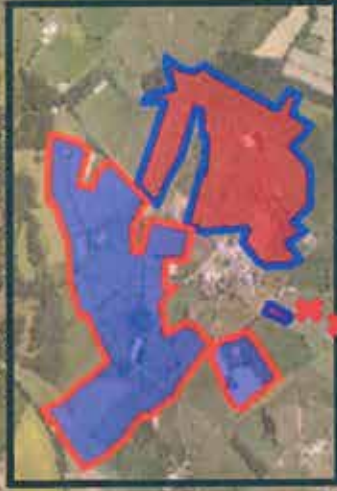
Solar farm 1 and 2

- Mining tunnels are not shown as they were not always mapped, but need to be investigated, along with shafts and bore holes
- "Stowe by Chartley PC" have evidence of a further 4 sinkholes, along with mine shafts. However, the landowners have requested their details are not disclosed at this stage. Please see attachment 4 for further information.

- ATTACHMENT 1 - A plan of the area, indicating the three solar farms, and shows the sites of some of the sink holes. NB: Mining tunnels are not shown as they were not always mapped, but need to be investigated, along with shafts and bore holes.
- ATTACHMENT 2 - Individual statements from those who have witness these sink holes.
- ATTACHMENT 3 - A report from the Staffordshire Industrial Archaeological Society in 2008, regarding Oakfield Farm.
- ATTACHMENT 4 - Photographic evidence and a short summary of each sink hole.
- ATTACHMENT 5 - Staffordshire County Council report on Normanswood Farm, dated on 8<sup>th</sup> June 2006.

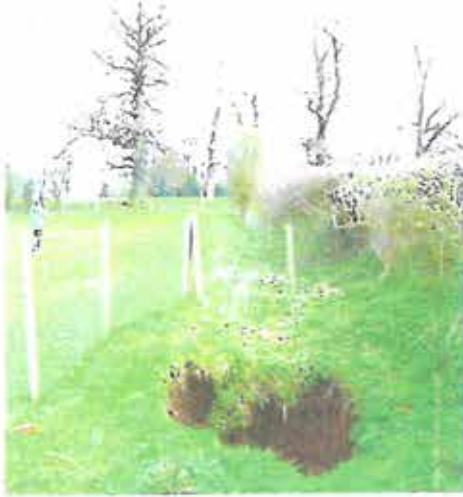
Figure 1. Hole at edge of field

In 2008 Mr George Hampson of Oakfield Farm, Lea Lane, Adbaston was spreading manure on his field when a large hole appeared at the edge of the field in the top NE corner.

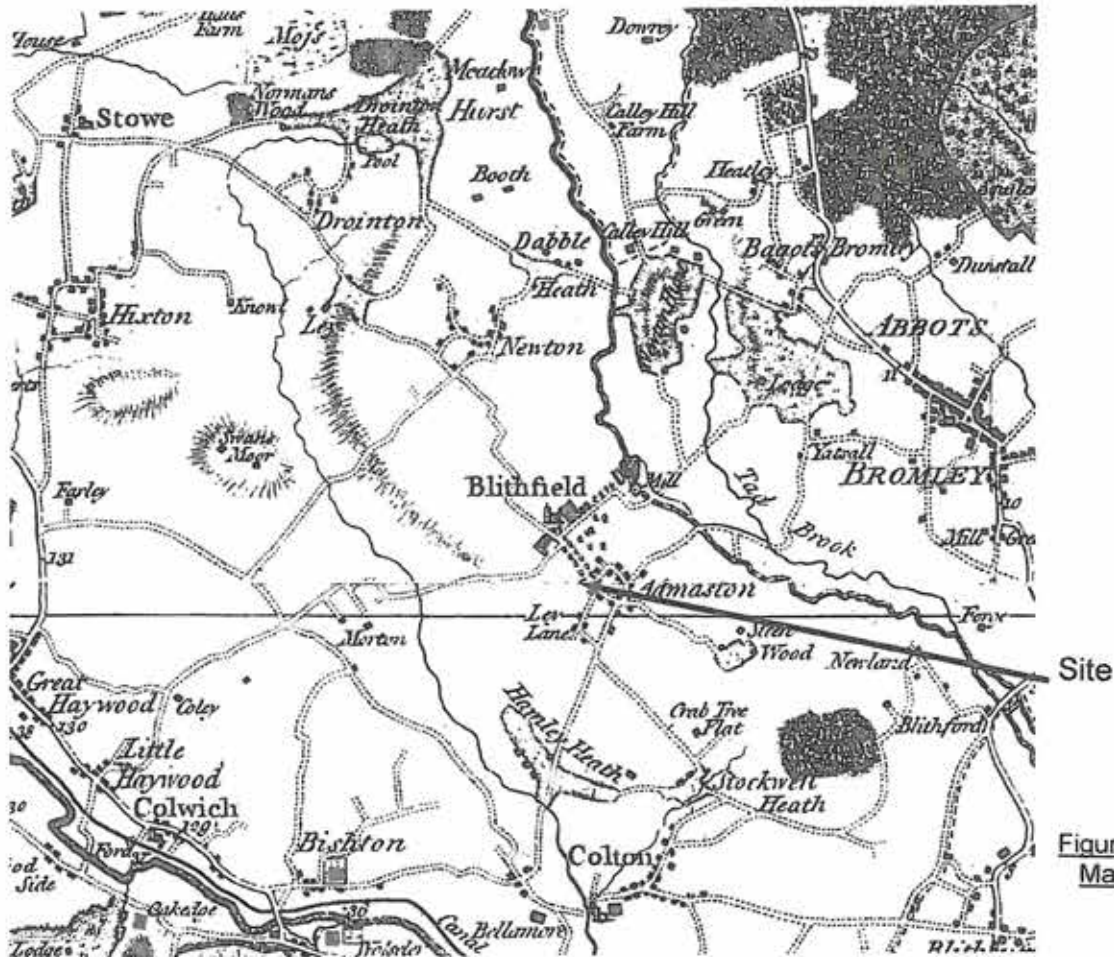
The earliest map of the area, Yates 1775, shows the road to Newton as a continuation of the lane to Steen Wood, crossing the Rugeley to Abbots Bromley Road at Admaston, and then continuing past Blithfield Church to Newton, Figure 2. Lea Lane, shown as Ley Lane is a short road forming two sides of a rectangle to join the above Admaston to Newton Road.

Figure 3 Yates  
Map of 1775

The line of this road now appears as a hollow way running down the side of Oak Field and adjacent to the current hole.

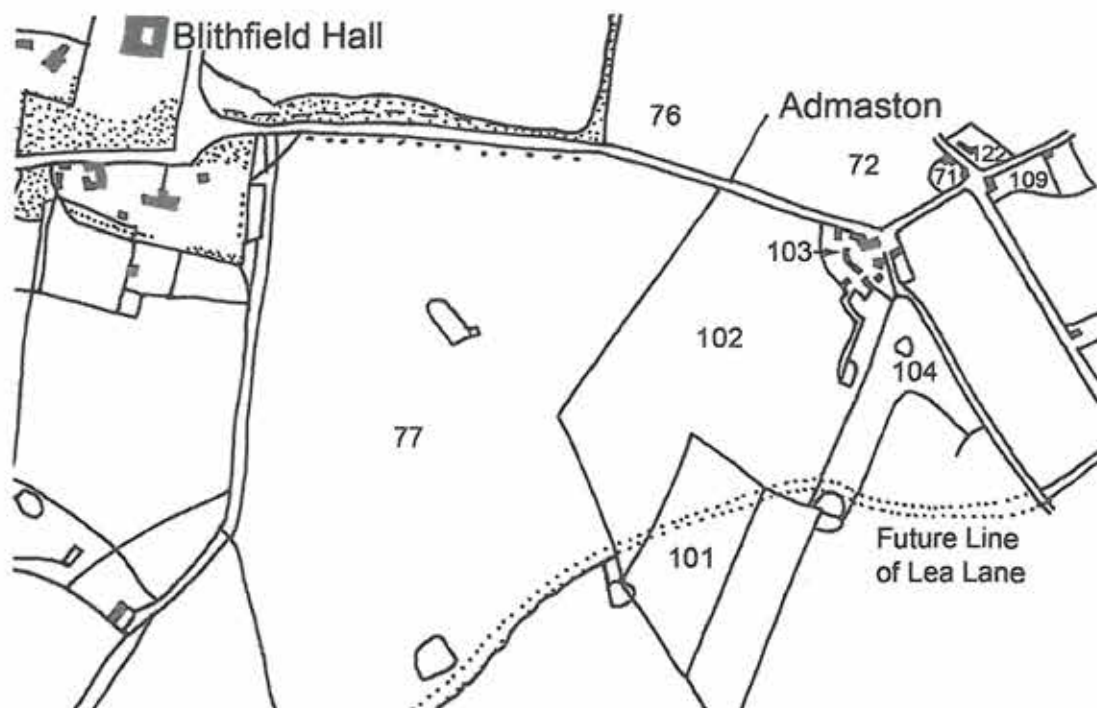
The next map of the area is a map of Blithfield Township, dated 1799<sup>6</sup>, this is very similar to an a very large undated map of the Bagot Estate, which must come from about the same time<sup>7</sup>, part of the latter is shown in Figure 5. The 1799 map show only the first part of the proposed line of Lea Lane as far as the first marl pit, whereas the undated map shows the whole route. They both show the same road parallel to the main Admaston road, off Lea Lane going up the side of the field along the line of the ditch, .i.e. the Hollow Way. Two or three of the present 5 pits on Oakfields Farm land are shown, including the present "Sluice Pit" with water in it. The fields are numbered, but there are no corresponding schedules giving their names, sizes and tenants. The main Oakfield is numbered 77 and the field containing the hole, 102.

Figure 5. Area around present hole taken from a Map of the Blithfield Estate c1799

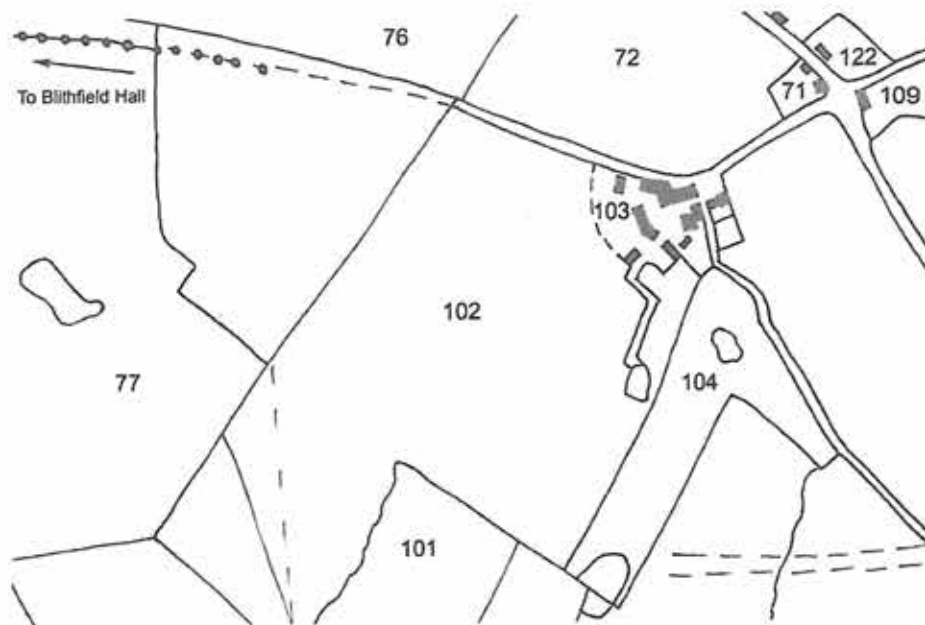
Both maps show a collection of about 7 buildings in the top corner of field 102 where the present hole is, Figure 6, with a track leading down to one of the pits below the present hole. These buildings could be associated with a brickworks, using marl from the pit to produce bricks for building work on the Estate. However, there is no documentary evidence to support this. Marl was also used in agriculture to improve soil condition by reducing the acidity and improving soil texture.

Both maps show a building in the top corner of the next field, but only the undated map shows a further building or structure on the field side of the Holloway nearer Lea Lane.

Figure 6. Area around present hole taken from the 1799 Map of Blithfield Township enlarged to show buildings in top corner of field

The 1846 map shows a farm at Oak Fields for the first time, with a very large field containing 4 marl pits including the sluice pit, and a triangular wood, accessed by a footpath from Lea Lane. There is no sign of any of the smaller sub-divisions into crofts, or of any buildings in this field. The drive to Blithfield Hall has been realigned and the two lodges built on either side of the entrance gates. Interestingly the kink in the hollow way field boundary, shown in Figure 6 as the point where fields Nos. 102 and 104 met the hollow way, is still visible.

There was no sign of any man made structures in the sides of the hole, although there were a few bricks which appeared to have come from the surface – possibly the remains of some of the buildings shown on earlier maps (See Figure 6).

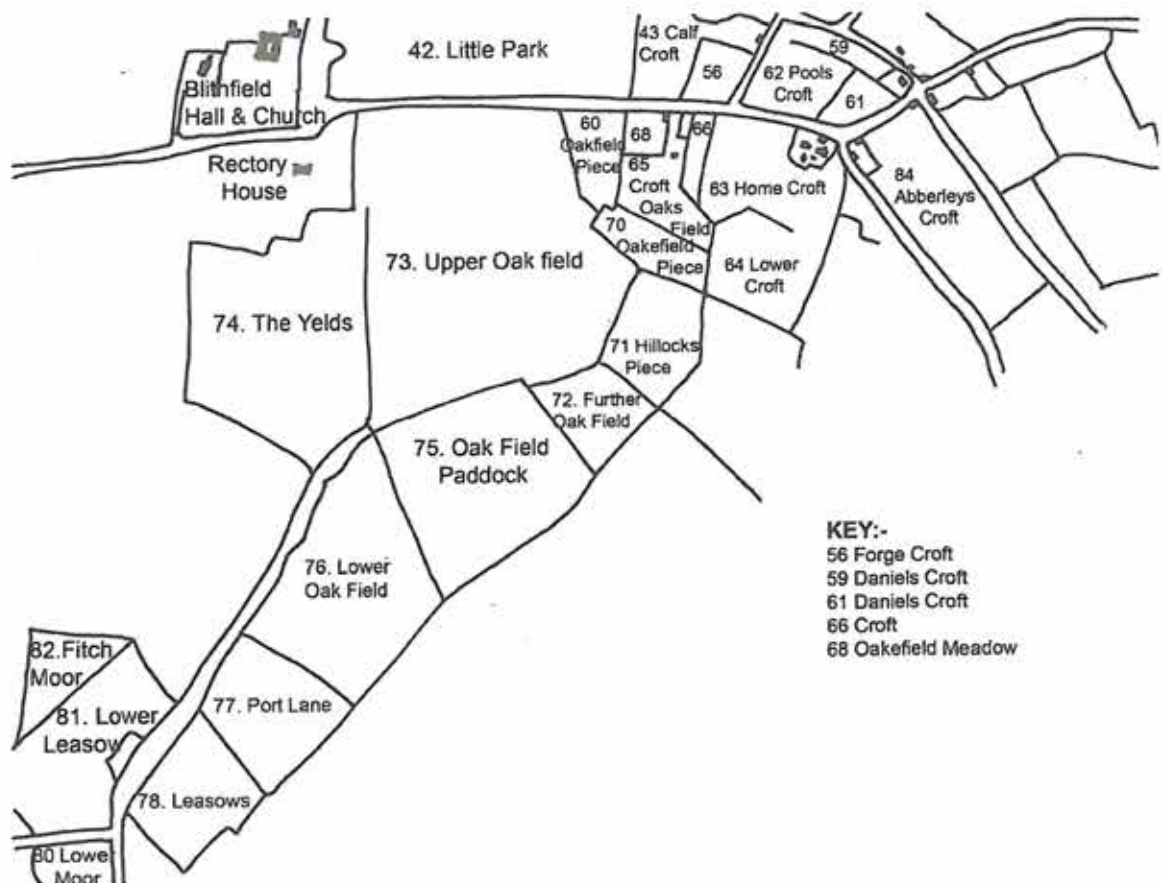
Another map of about the same time as it does not show the extended Lea Lane, is present in a volume of maps of the Estates of Sir Walter Wagstaffs Bagot<sup>8</sup>. This shows the rectangular grid of roads leading to Admaston, and it shows the field names, Figure 7. However field 102 has now been subdivided into a number of small crofts. There are 5 buildings by the site of the present hole in Home Croft and two in Abberley's Croft on the other side of the hollow way.

Figure 7. Part of a map from Sir Walter Wagstaffs Estates at Blithfield Township showing the field names

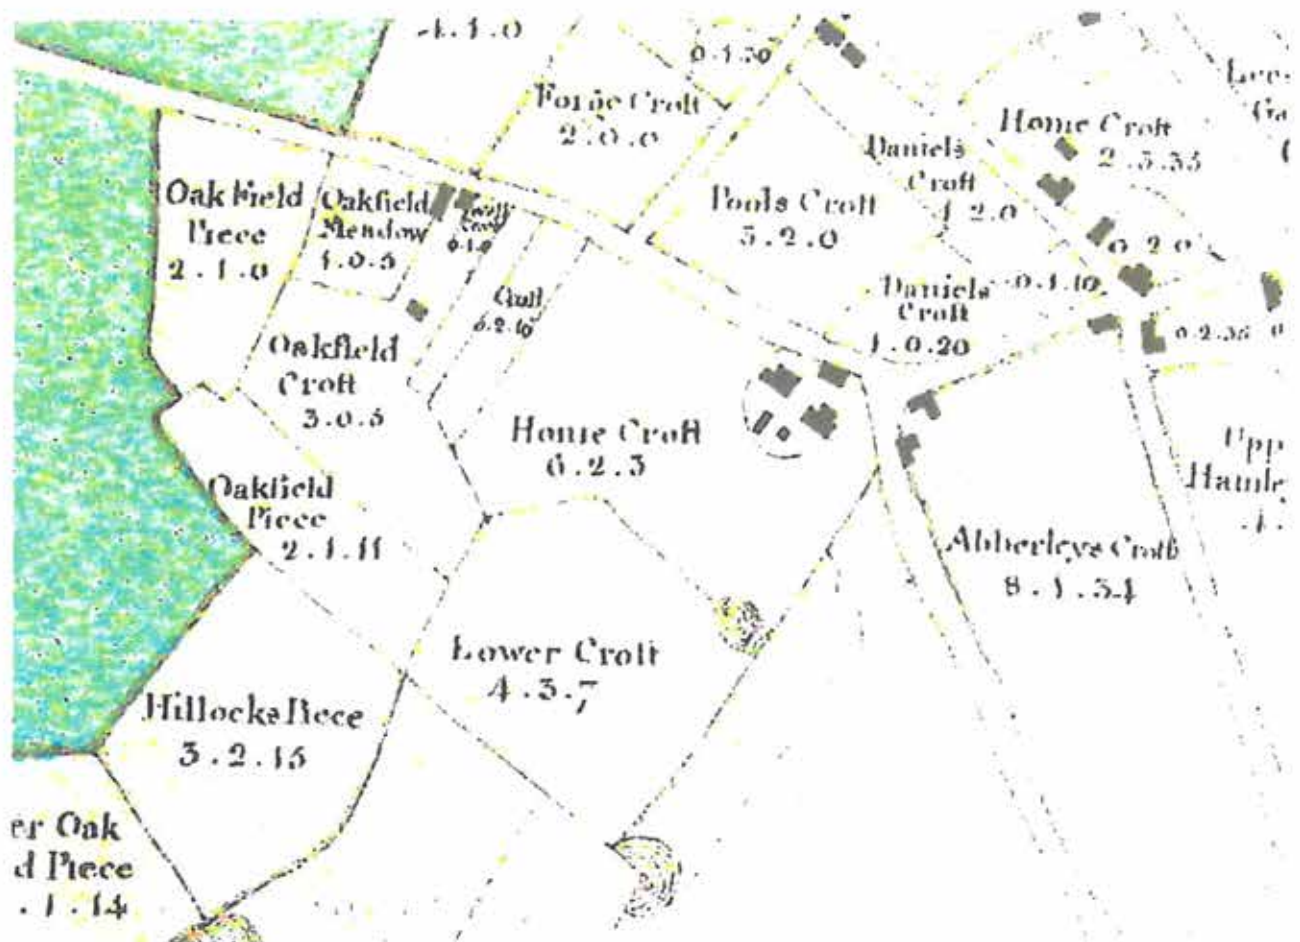
Another similar map of Blithfield Manor with 1810 added in pencil appears to be a copy of Sir Walter Wagstaffs map.<sup>9</sup> The demesne lands occupied by the Manor are shaded, Figure 8. This map confirms that the fields not shown at the bottom of Figure 7 were part of Colton Lordship. This includes the lower part of the field containing the hole.

Figure 8. Part of a map from the Blithfield Manorial Survey [1810] enlarged to show the area around Home Croft.

There is generally good correlation between the field names, numbers and acreage between the three surveys dating from 1762 – c1810, Appendix 1. The area shown in Figure 8 is of particular interest. Although the 1799 maps, Figures 5 and 6 show field 102 apparently undivided, all three surveys show Home Croft, No.63, 6a.2r.3p occupied by George Holland who occupied a large holding of 328 acres – possibly the Blithfield Home Farm. Abberleys Croft in the adjacent field is similarly shown as No.84, 8a 1r 34p occupied by Joseph Hodgson who had a total of 72 acres.

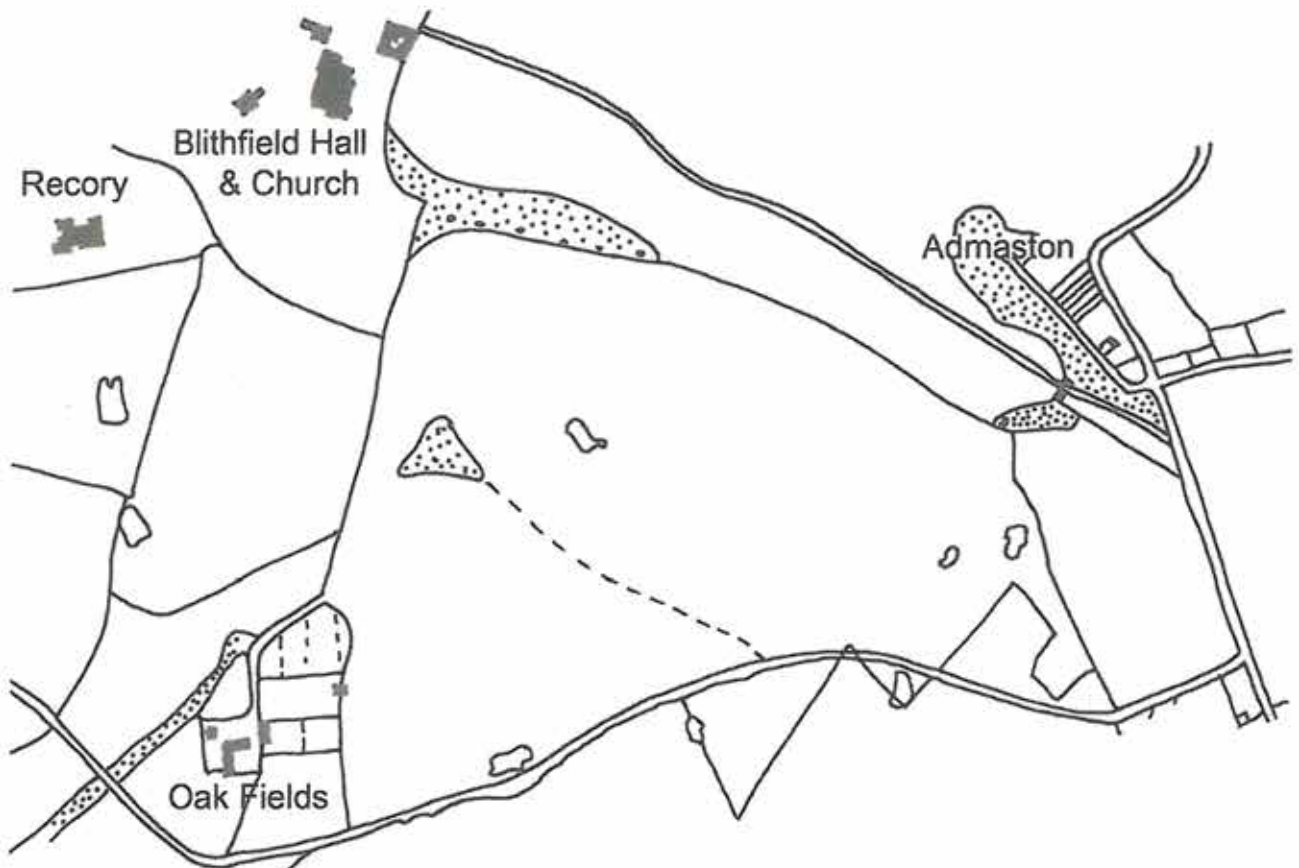
Figure 9. Part of an 1846 Map from the Blithfield Parish

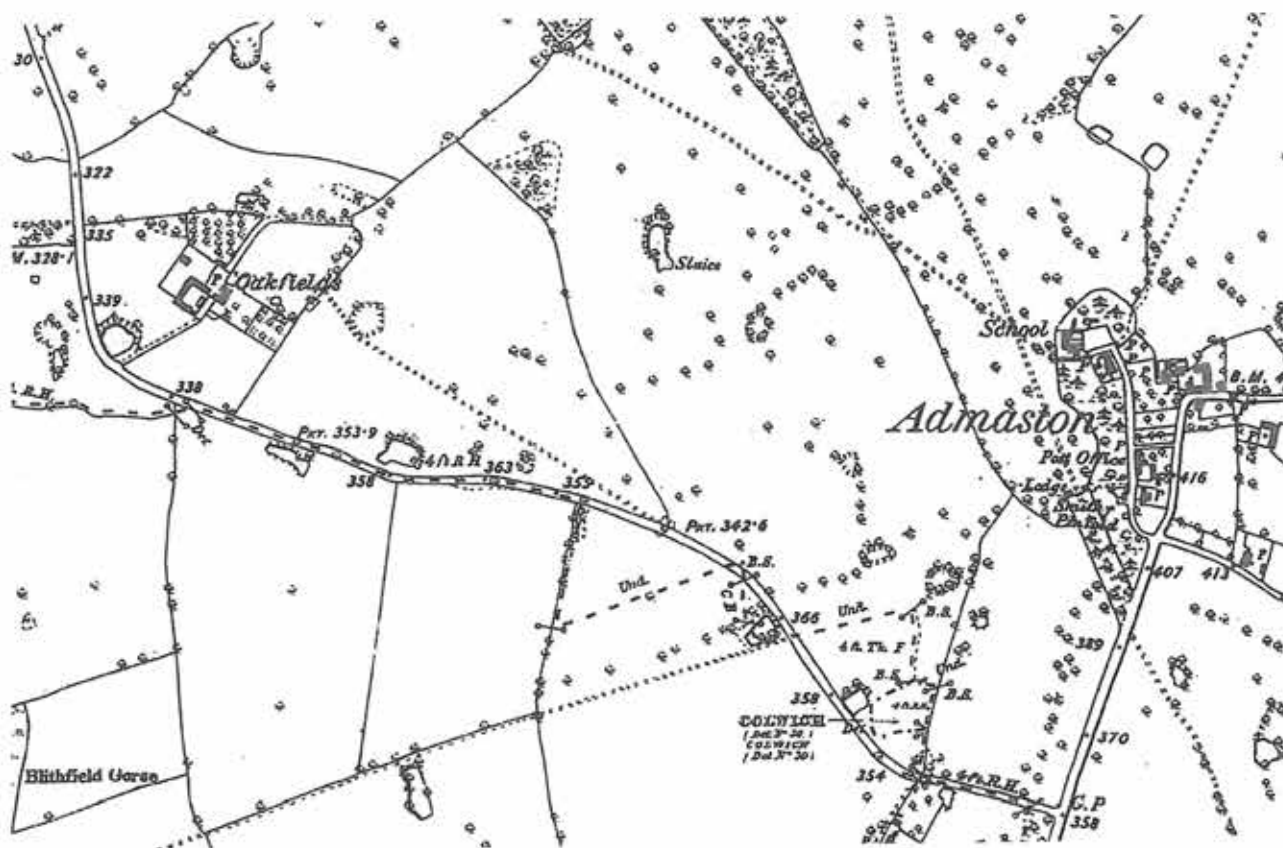
The first edition of the 6 inch to 1 mile Ordnance Survey Map is dated 1884 and shows the line of pits and the kink in the field boundary near the hole.<sup>17</sup>

Figure 10. Part of the 1884 1<sup>st</sup> Edition 6inch:1mile Map showing Admaston and Oakfields Farm  
Blithfield Hall and Church are off the top of the map.

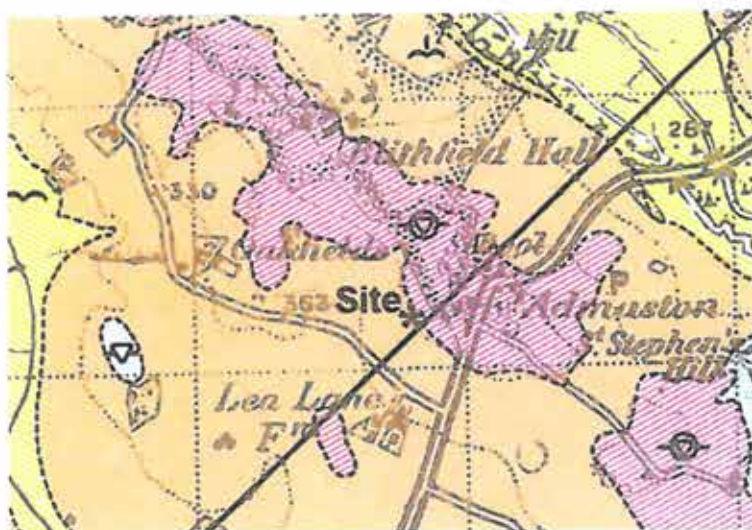
Figure 11 Geological Map of area around the hole<sup>18</sup>

Admaston is situated on the Keuper Marl, now known as part of the Mercian Mudstones, Figure 11.<sup>18</sup> Gypsum has been mined at Tutbury, ~10 miles to the north east and at Stowe by Chartley ~3½ miles to the north west.

- Keuper Marl or Mercia Mudstone, f6
- Glacial Sand and Gravel
- Alluvium

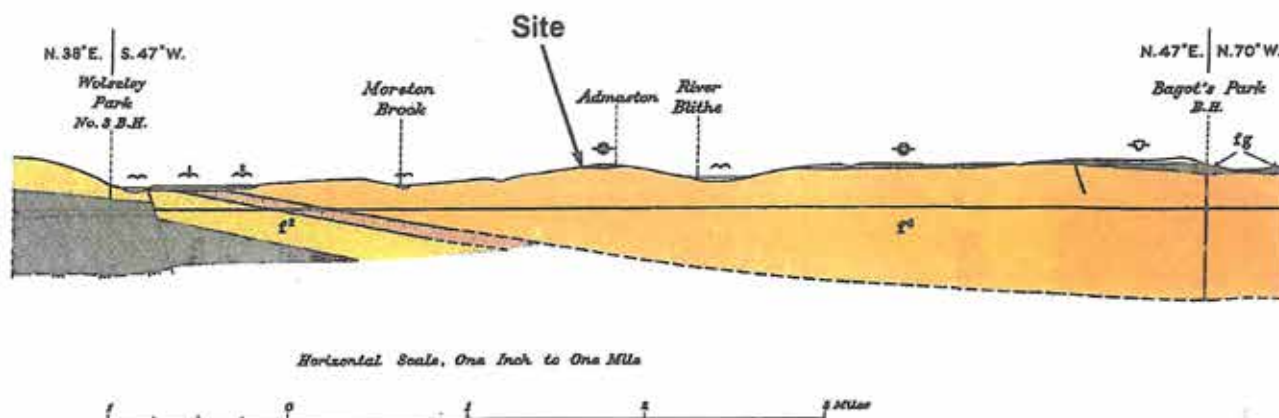
Figure 12 Geological section through area around the hole (See Key for Figure 11)<sup>18</sup>

The line of the section, Figure 12 is shown across the map.

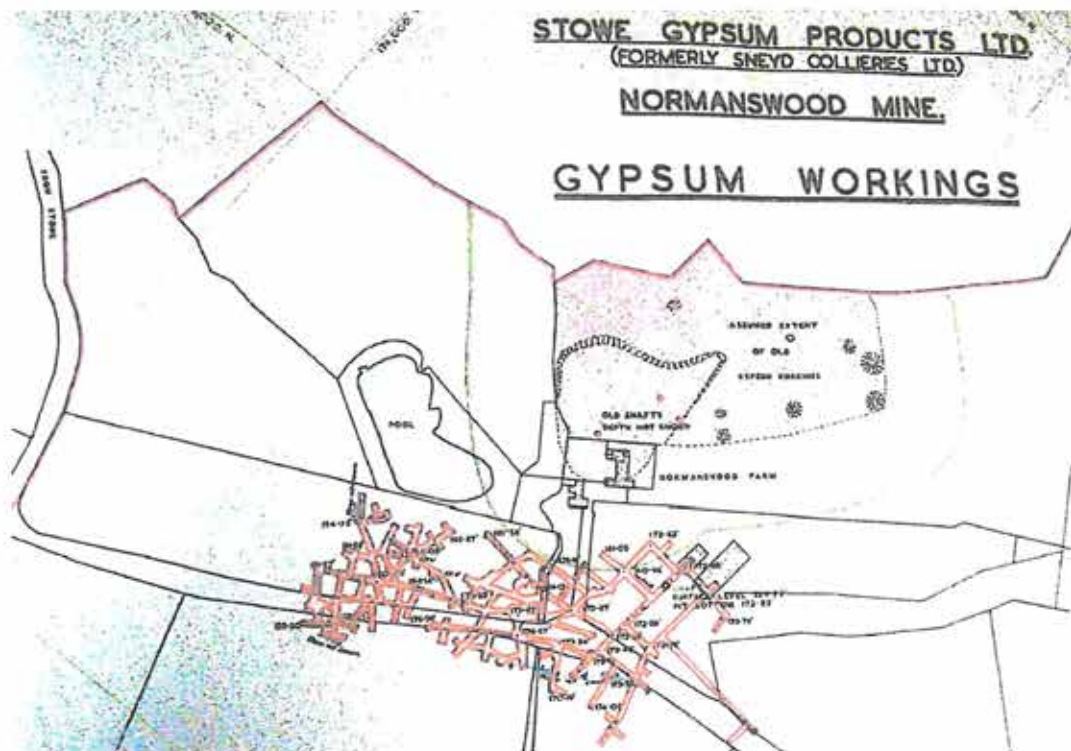
Figure 13 Plan of Gypsum Workings at Normanswood Farm, Stowe by Chartley

A 1956 plan shows the old and later Gypsum workings at Normanswood Farm near Stowe by Chartley, Figure 13 <sup>23</sup>.

According to information on Staffordshire Past-track the "Gypsum was sent to London to make castings, especially for dentists." They also noted that the 165ft deep shaft was very wet and had to be pumped out 18 hours /day. <sup>24</sup>

In order to investigate whether the hole was part of earlier Gypsum mining activity as shown in Figure 13, the area of the field was investigated by dowsing. Dowsing has been shown to be effective in detecting underground cavities and water<sup>28</sup>, Figures 19 and 20.

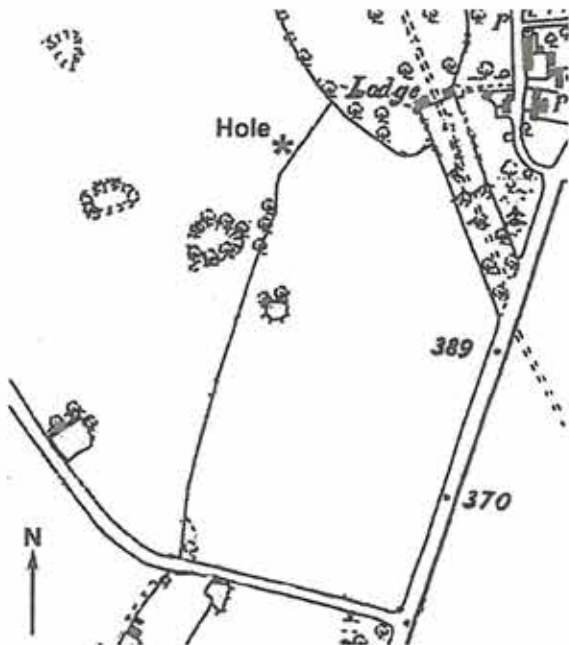
Figure 14 Map showing location of hole

The location of the hole which appeared in Mr Hampson's Field is shown in Figures 14 & 15. It was located 103ft or 31.394m from the northern boundary of the field and 6ft or 1.829m from the adjacent hedge.

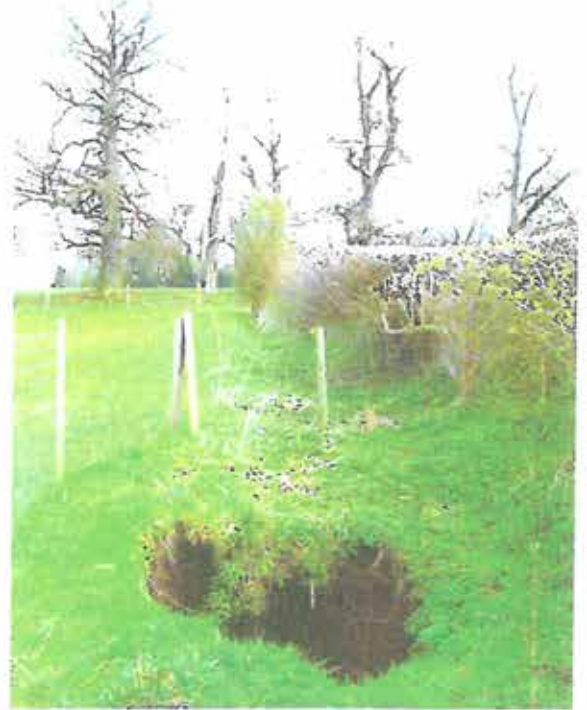
Figure 15 Looking to top of field from hole

The hole was irregular and elongated on its north-south axis. It measured a maximum of 7ft or 2.134m across at the surface and 9ft across at the base, 15ft 6ins or 4.724m below ground surface. The width was 2.13m and it was a minimum of 1.83m from the hedge.

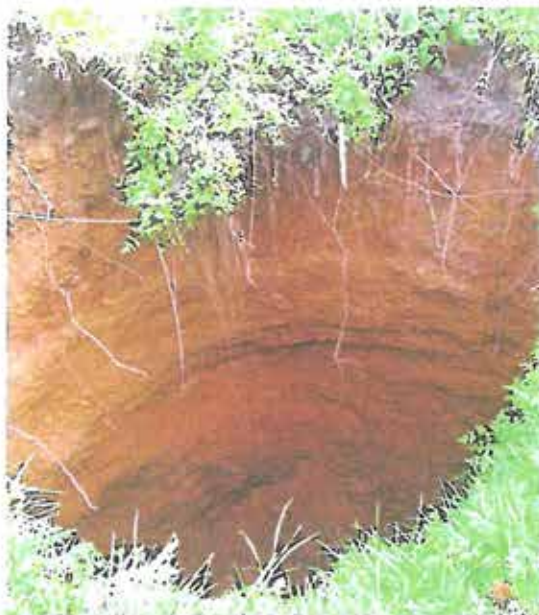
Figure 16 Hole looking towards south west

From the surface the walls of the hole showed a succession of layers of glacial gravels overlaying the Keuper Marl, Figure 16. On descending by ladder into the hole, Figure 17, the bottom of the hole as seen to be filled with the field surface which had fallen vertically down into the void.

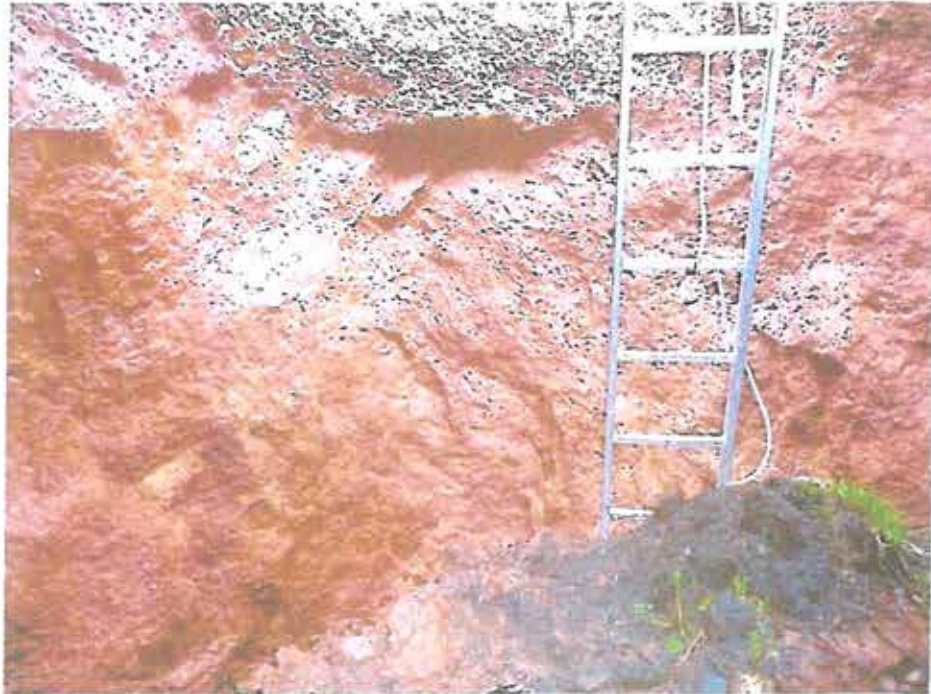
Figure 18 Side of the hole looking up from the bottom with ladder on fallen in surface material

There was no sign of any further voids leading away from the base of the hole. Figure 18 show more detail of the sides of the bottom of the hole.

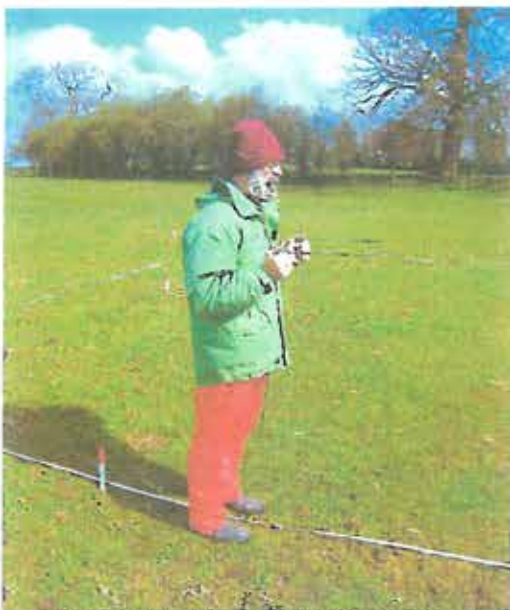
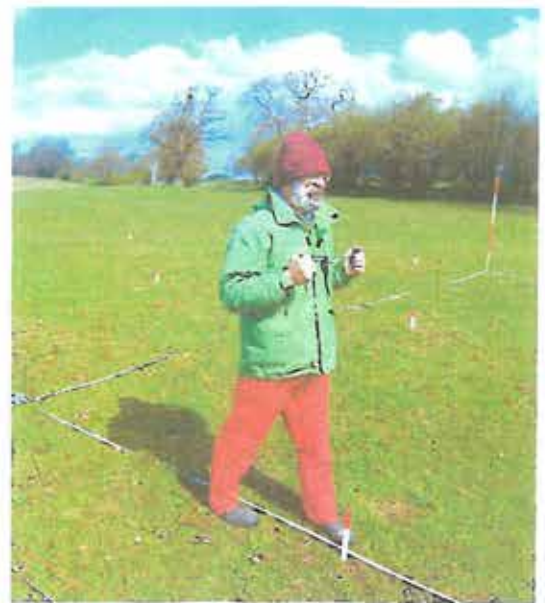
Figure 19 Dowser with rods uncrossed

Figure 20 Dowser with rods crossed

The dowsing rods cross when the dowser walks over the boundary from solid to a void.

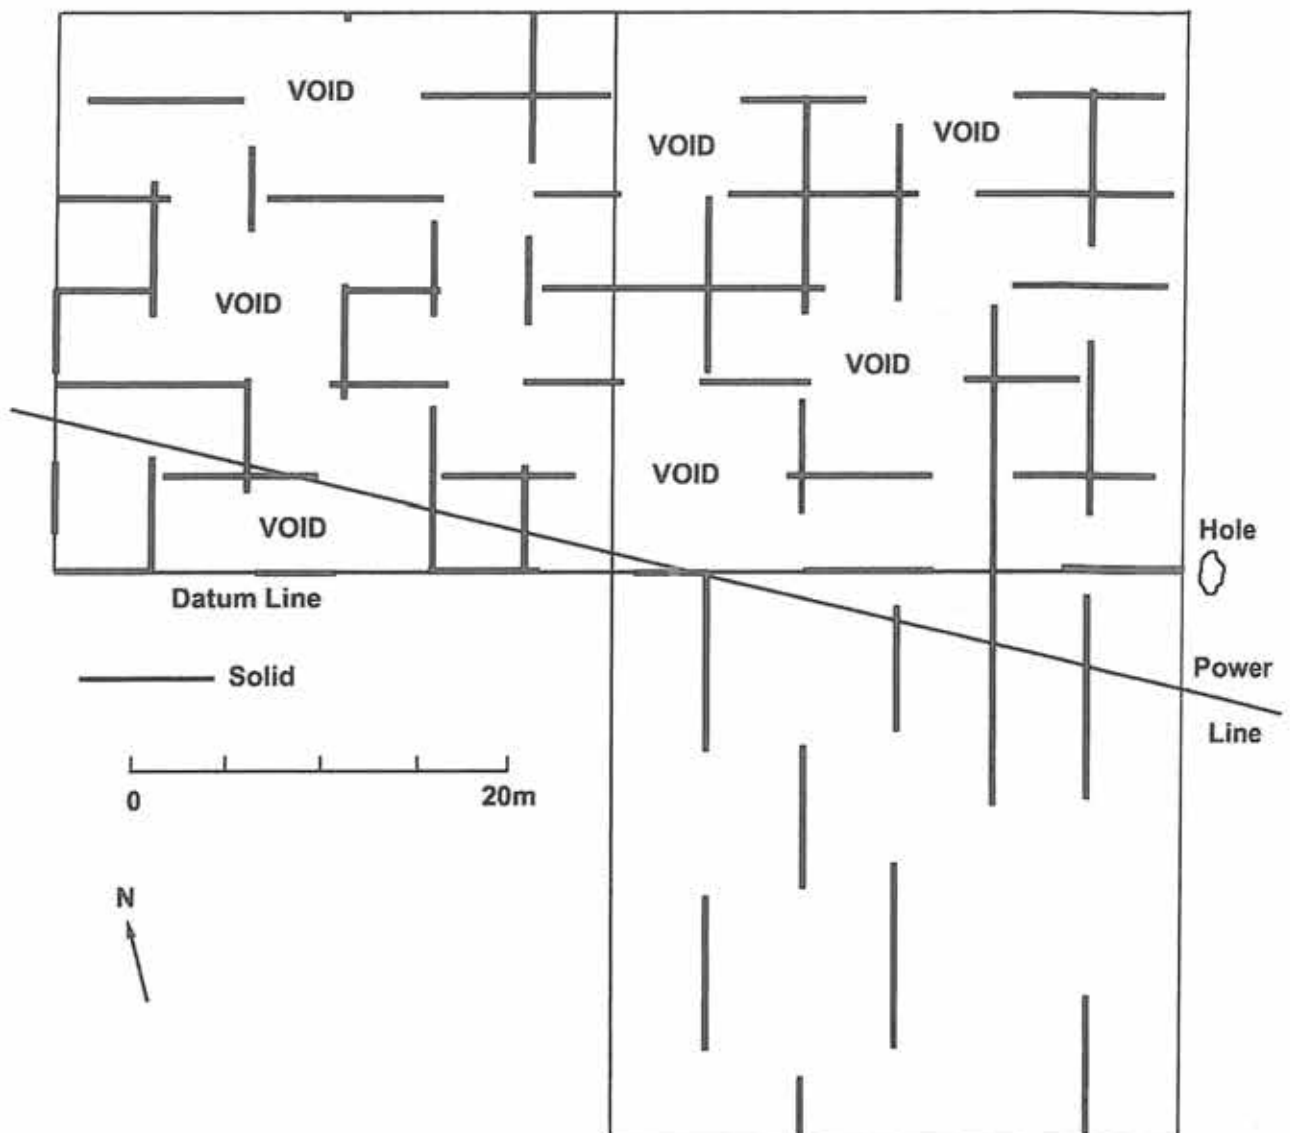
Figure 21 Results for dowsing the 30m squares adjacent to the hole

The area adjacent to the hole was lade out in three 30 metre squares from a base or datum line drawn out 5m from a post by the hole which was 3.96m from the field boundary and running approximately east west. Each 30 metre square was subdivided to form a grid at 5 metre intervals using tapes. The dowser then walked along these straight lines and when the dowsing rods moved a marking peg was inserted. The dowser then returned along the same to line to confirm the position of these changes.

The initial results for the 30m squares are shown in Figure 21. Not all lines of the grid were completed, i.e. East to west +30m and the 30m square south of the datum line; North to south 0 and 30m. Voids are only labelled when they appear in both directions.

The dowsing showed a lot of activity, but there was no evidence of any consistent pattern as would have been expected if Gypsum mining by the pillar and stall method had been carried out in the area. The power line did not have any observable effect on the dowsing results.

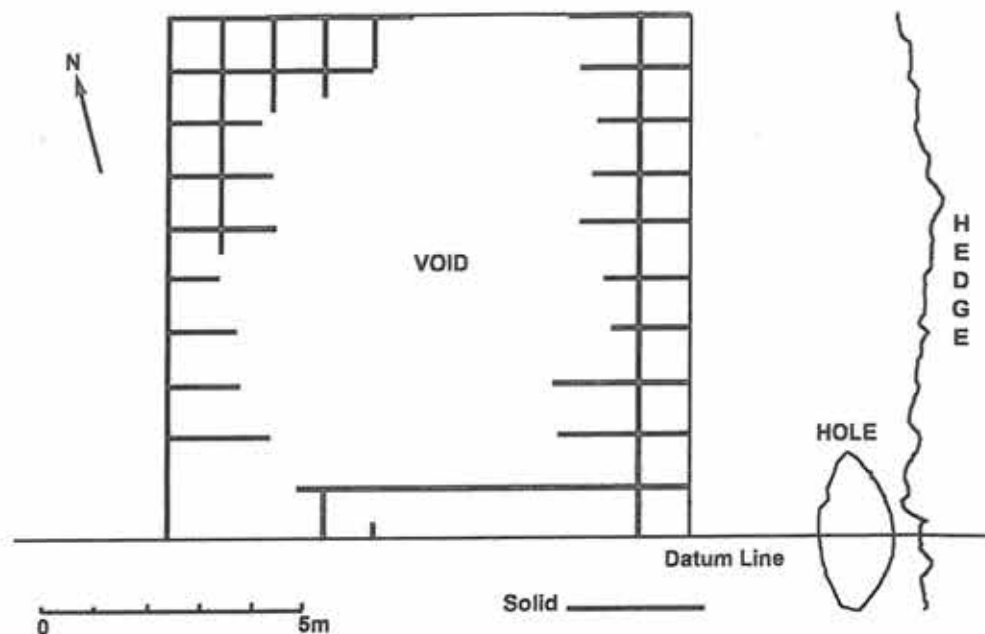
Figure 22 Results for more detailed dowsing of the 10m square adjacent to the hole

As an additional check, the 10m square immediately adjacent to the hole, i.e. to the north west, was subject to further dowsing with a 1m grid compared to the 5m grid used previously. The results are shown in Figure 22.

Unfortunately they did not correlate very well with the results from the original 5m grid for this area, although they did consistently show a central void. However, they were carried out some time later and underground water conditions could have changed.

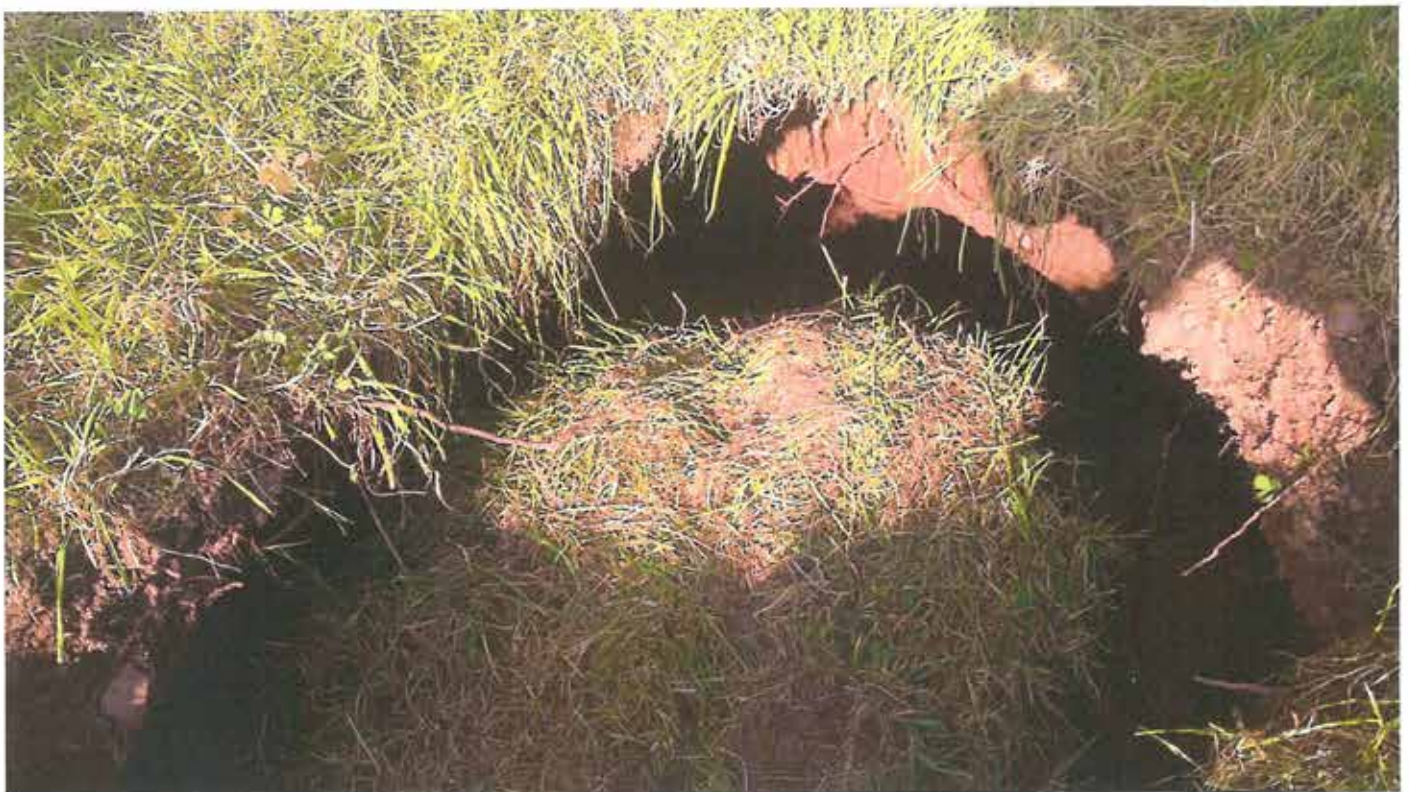
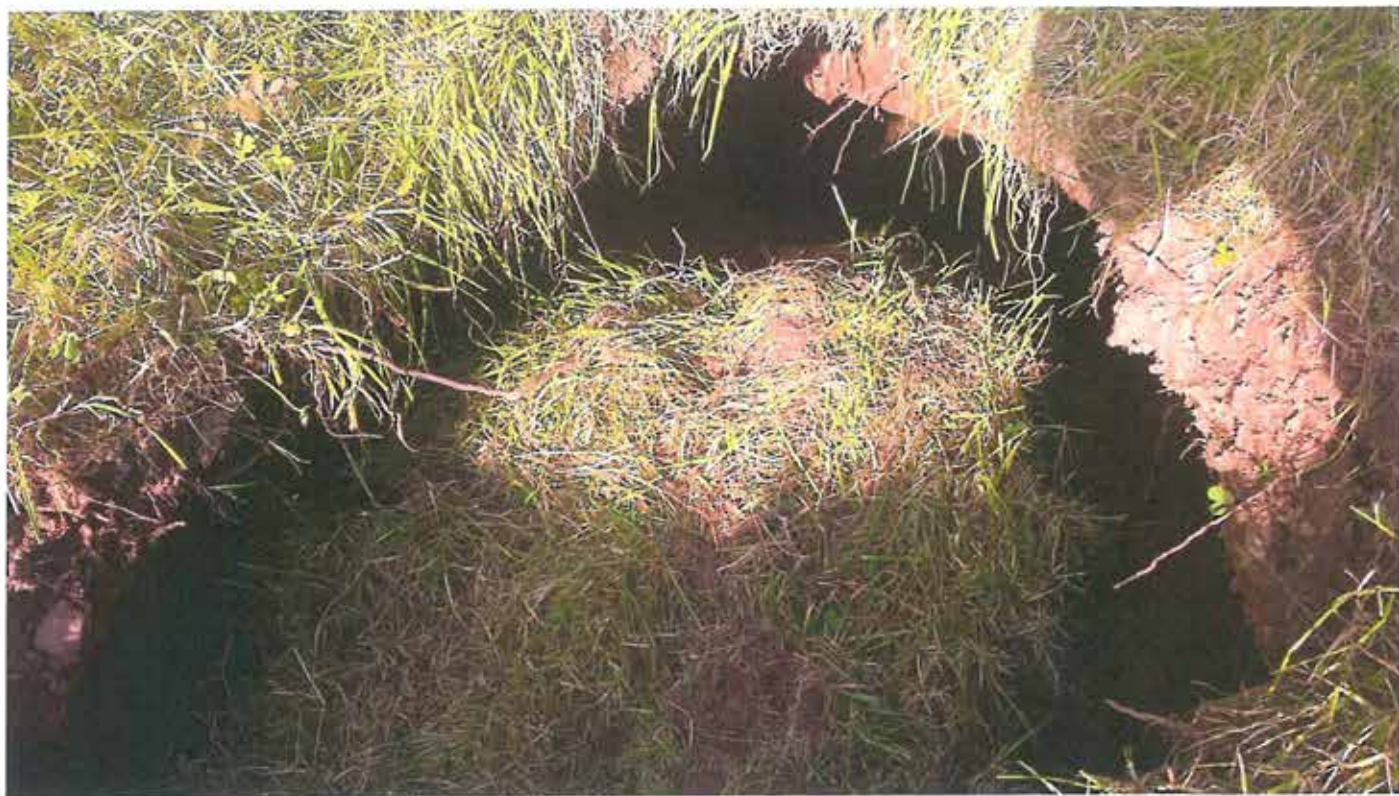
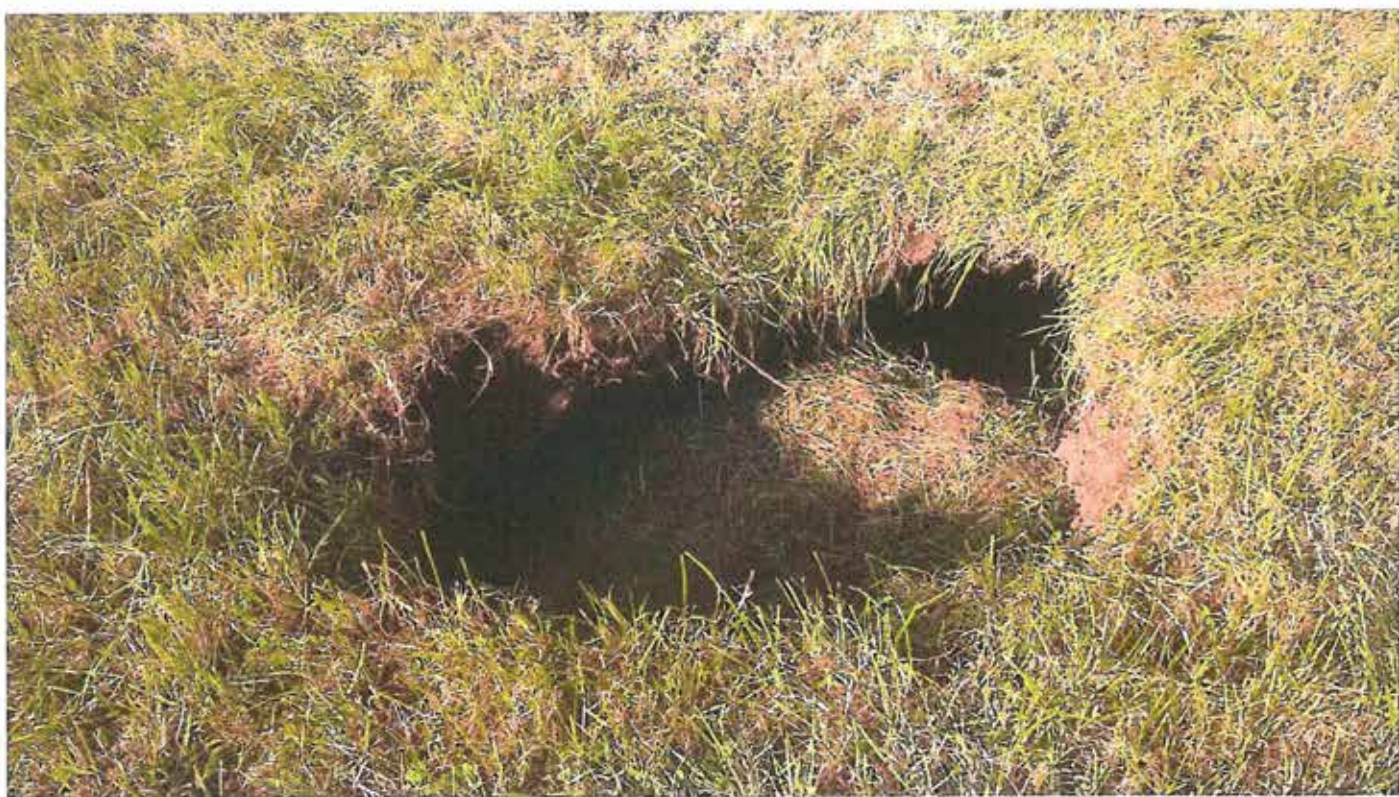
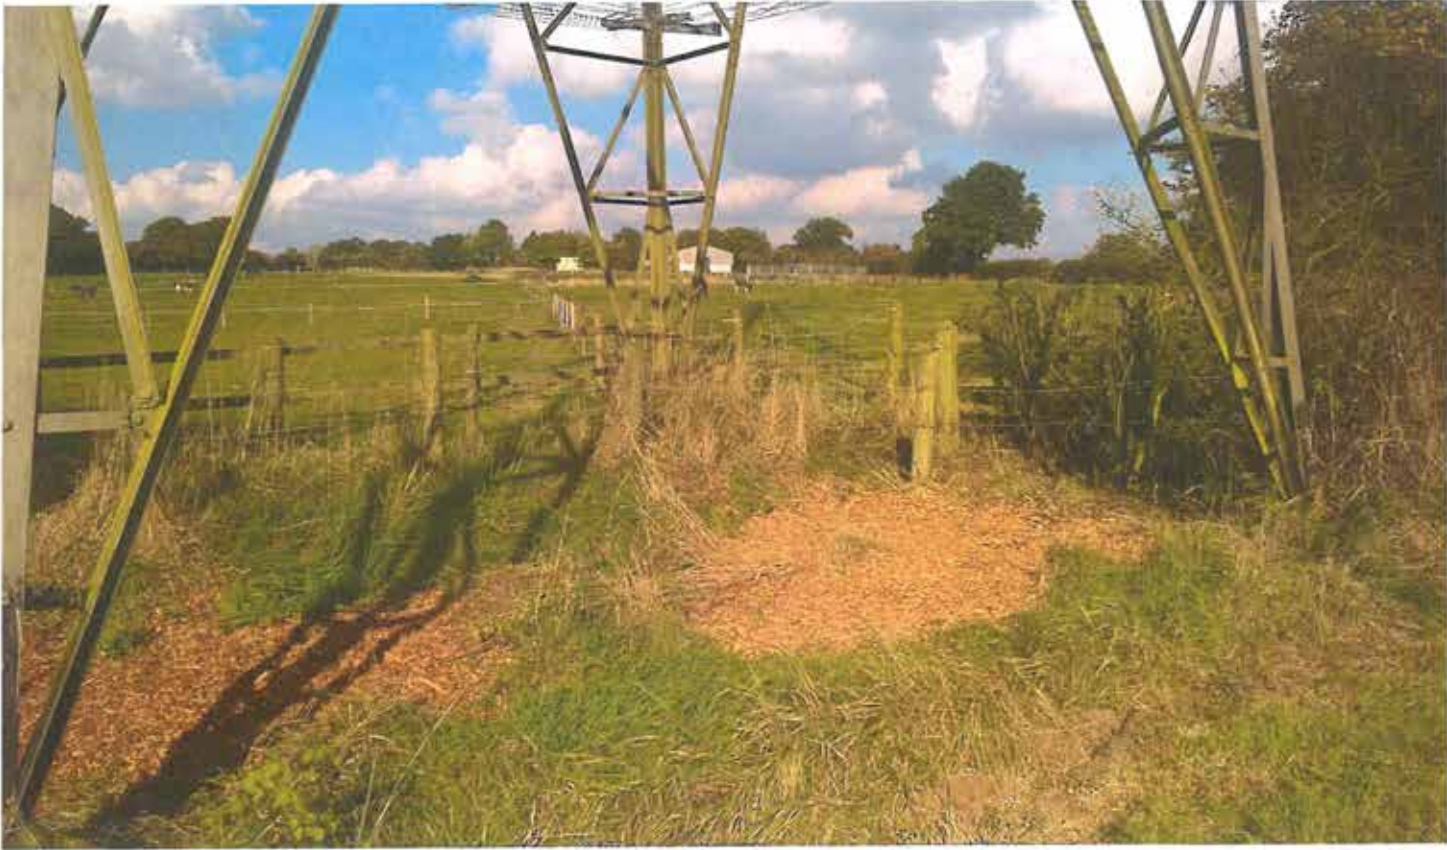
This sinkhole is situated on Brookside Farm, Lea Road, Drointon, and the land belongs to Mr Philip Gregory. The Sinkhole was approximately 8ft wide and 5ft in depth and appeared in 2010. An agricultural contractor was working in the field hedge cutting. He suddenly felt his tractor move and turned around to view his back wheels were sitting immediately in front of a large hole. This sinkhole is near to an electricity pylon.
