# *Stowe by Chartley Parish Council*

**Concerns with regards to proposed Solar Farms in Drointon, and Newton in Staffordshire.**

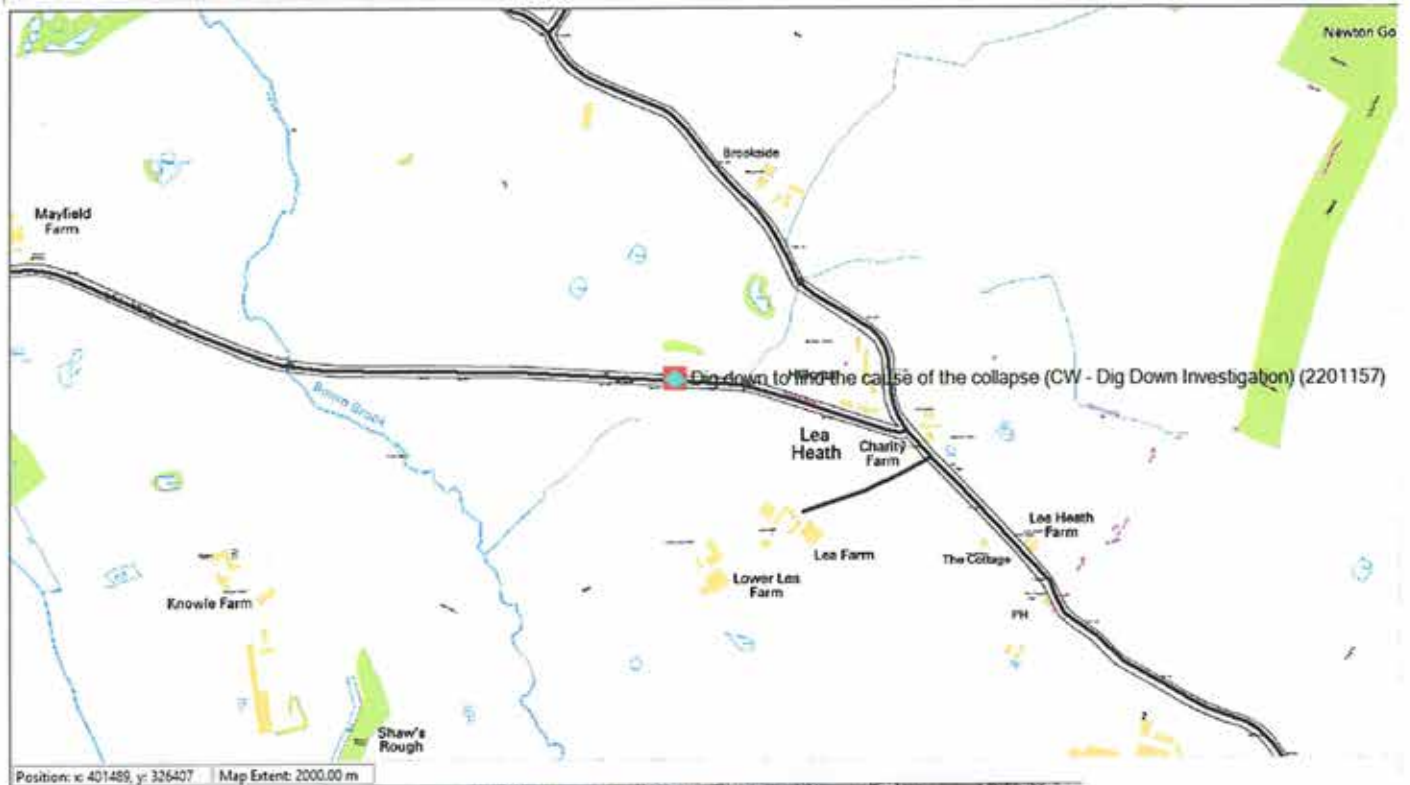
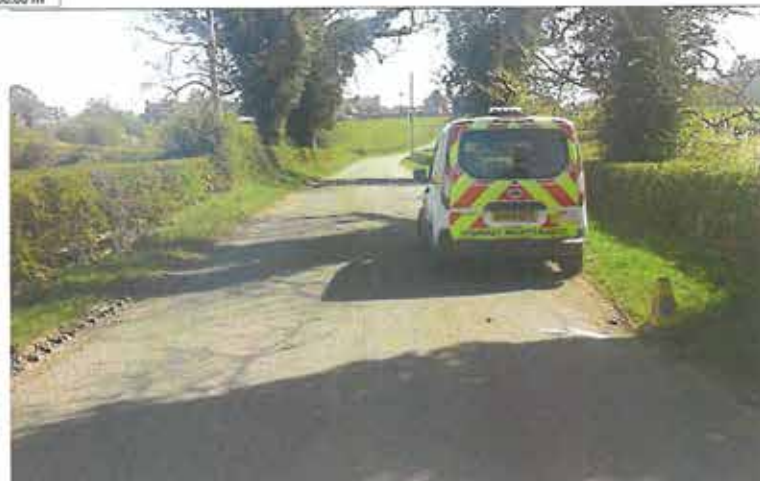
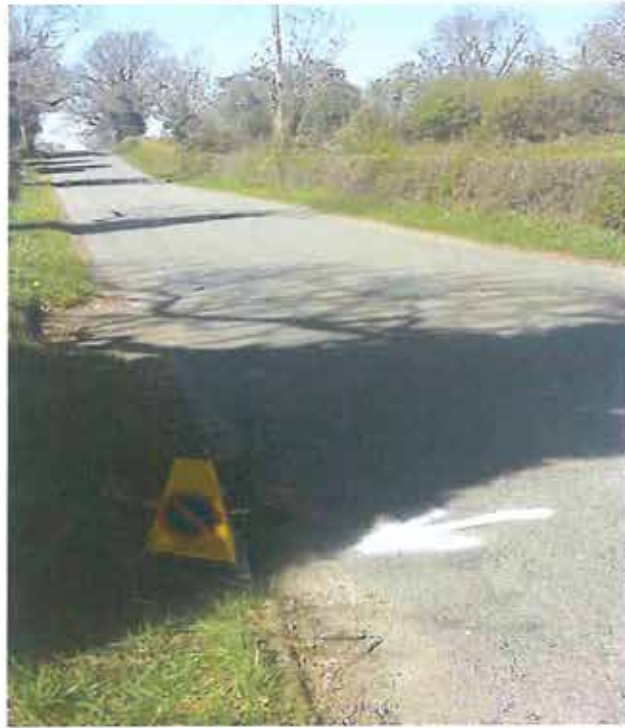
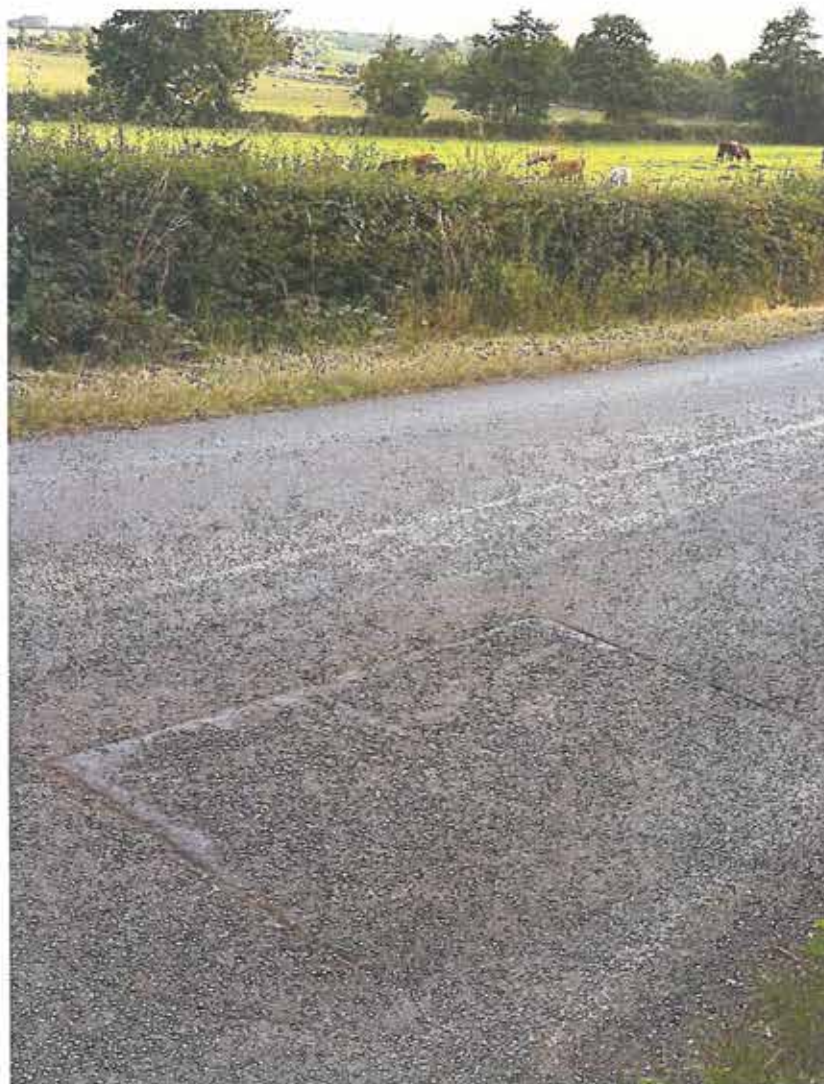
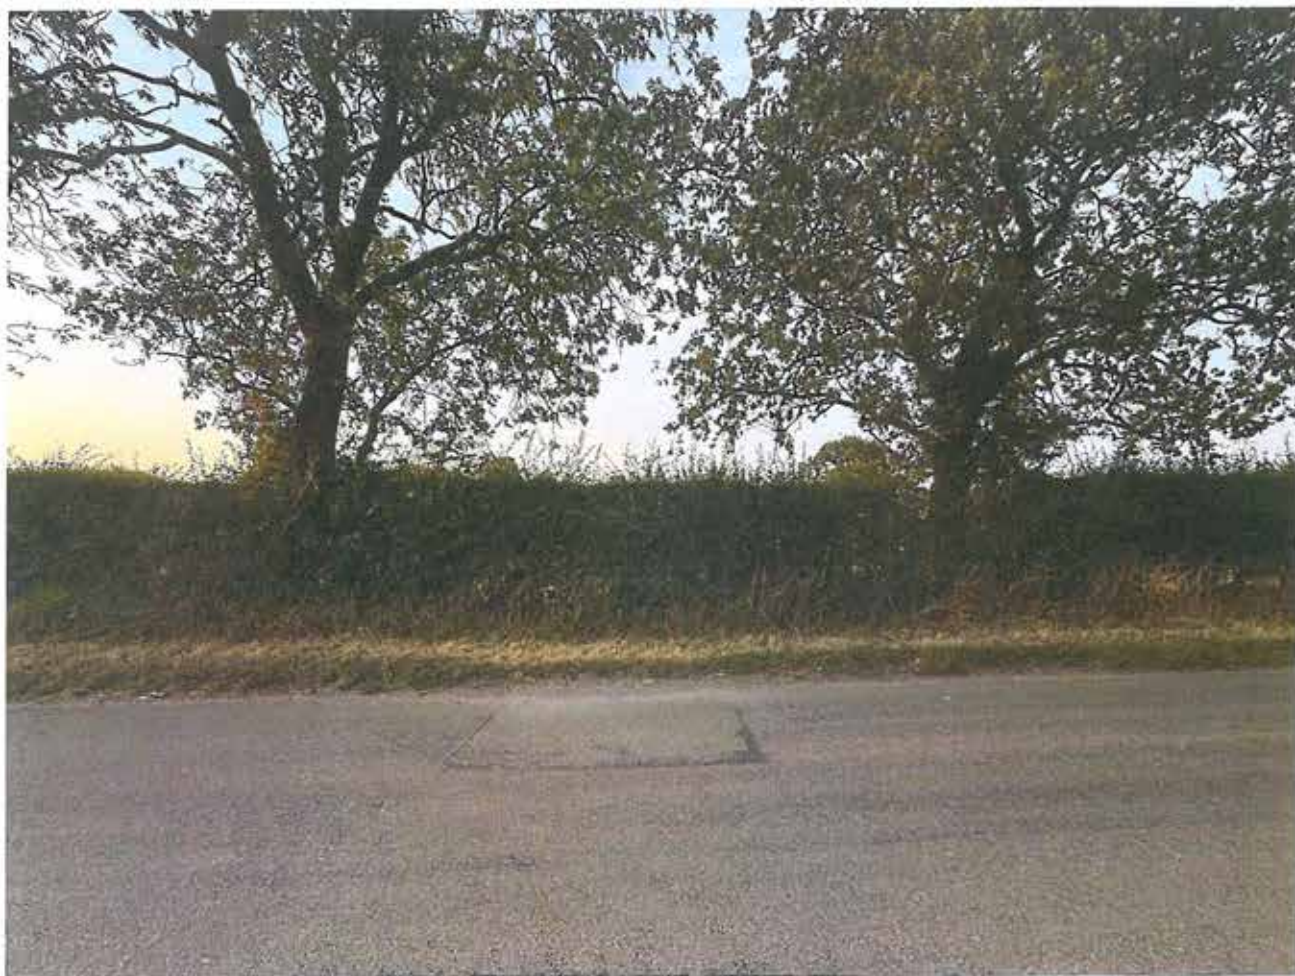
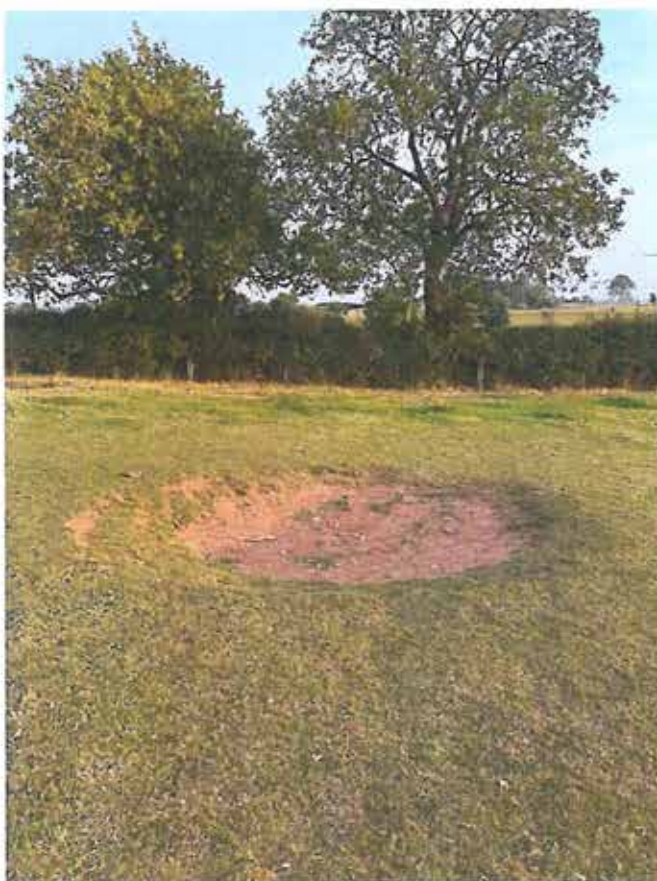
### **Sinkhole Number 3, 4 and 5**

This sinkhole appeared on the public highway at Lea Heath in 2020. The sink hole was approximately eighteen inches in diameter and approximately nine feet deep. A traffic cone was placed over the hole to make road users aware, until it was repaired by Staffordshire County Council Highways Department and eventually filled in.

A second sink hole appeared, approximately 20 years ago and it was further down Lea Road on the right-hand side travelling towards Hixon, approximately two hundred and fifty yards from the entrance to Knowle Farm, which also included a hole in the field the other side of the hedge, which is still visible today, as are the repairs to the road surface.
